Analysis of the Methods Used in Documentation of Historical Structures with Examples

Filiz KARAKUS

Yıldırım Beyazıt University

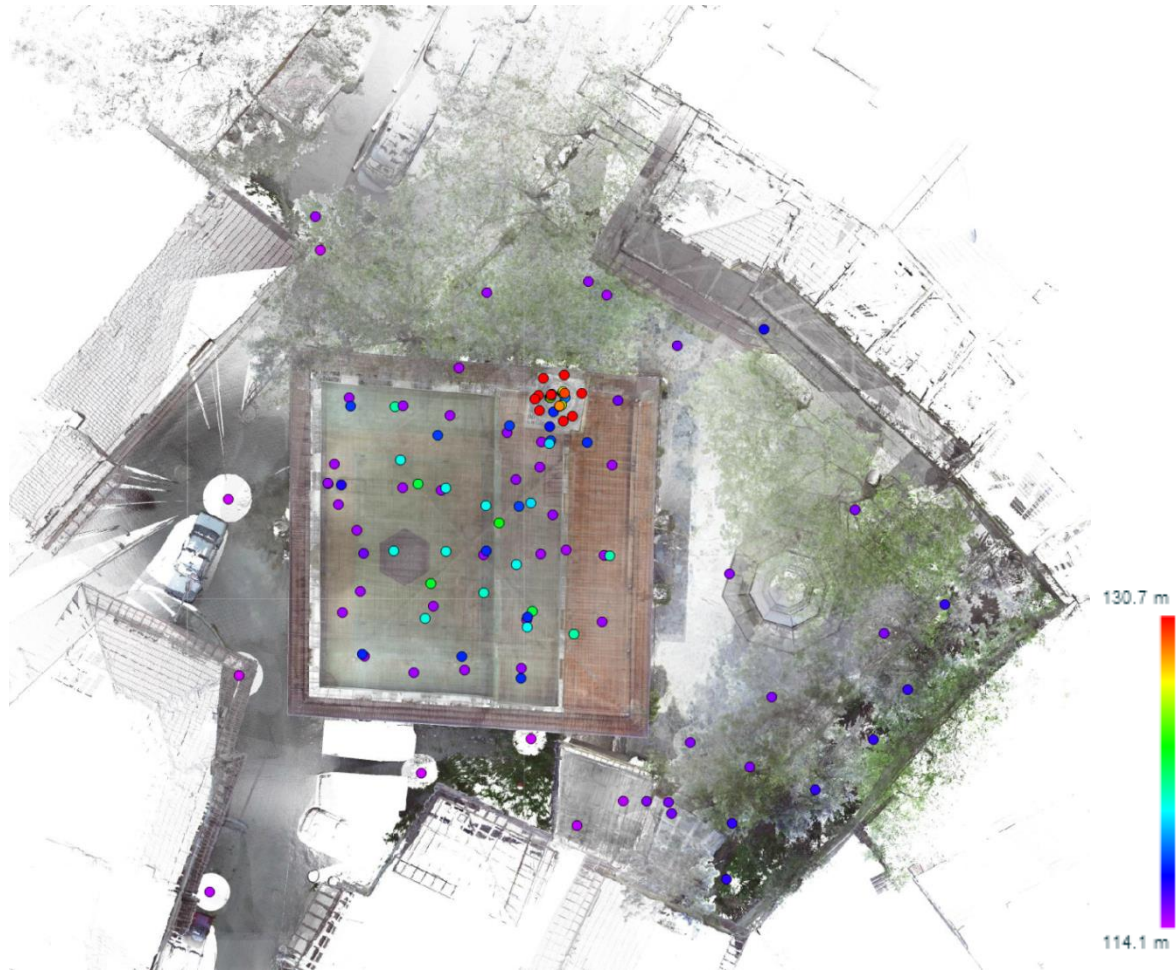
Figure 1. Points read with a laser scanner

The Buğdaypazarı Mosque, located in the Center of Çankırı, is located in the same courtyard with the Buğdaypazarı Madrasa. The survey, restitution and restoration projects of the mosque were drawn by Mithat Zafer Architecture Office. For documentation, FARO FOCUS X330 laser scanner with NIKON D80 camera, GPS, Altimeter, Inclinator, compass sensors and capable of measuring 122,000, 244,000, 488,000 or 976,000 points per second was used. For the drawing of the details, sketches were made and the measurements were taken on site with a tape measure and profile comb. 2056 photographs were taken to cover all points of the building. Laser scanning was done in color and black and white at 120 points and processed and combined with FARO SCENE software.

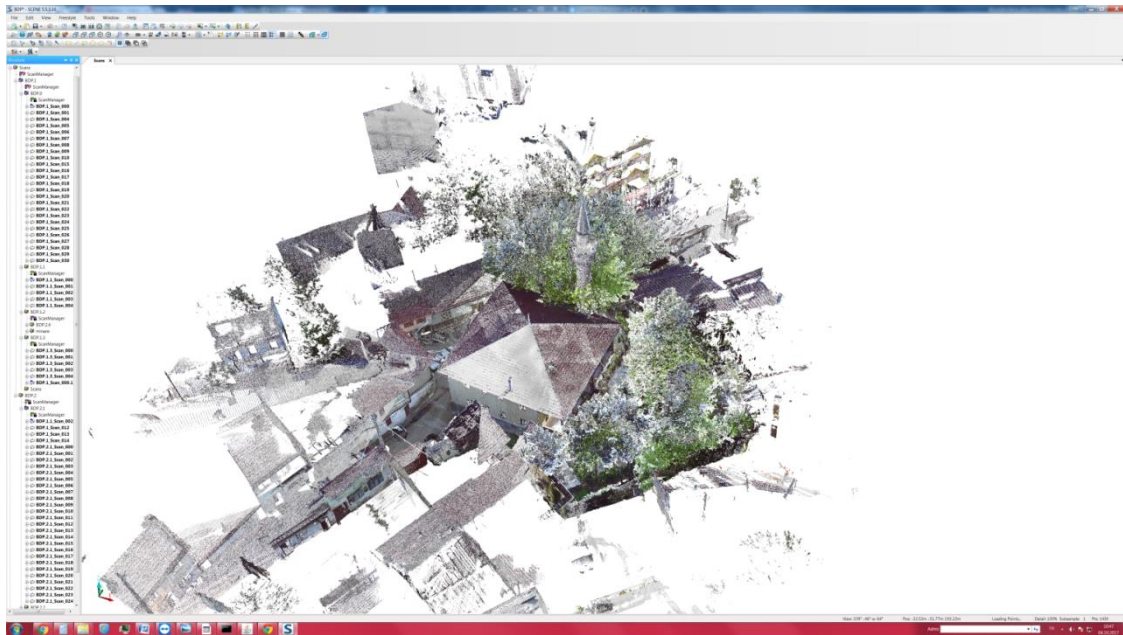
Figure 2. The combined point clouds are transformed into drawing

The combined point clouds were transformed into drawings in Autocad. For the decorations on the ceiling, orthographic photographs were obtained by wearing photographs on the point cloud and detailed drawings were

made on them. Among the photographs taken, the ones to be used in the album are numbered and shown on the key plan together with the shooting directions. At the stage where the measurements were taken and the drawings of the building were made, written and visual documents related to the building were reached and archive research was conducted. Based on these, an art history report of the building was prepared.

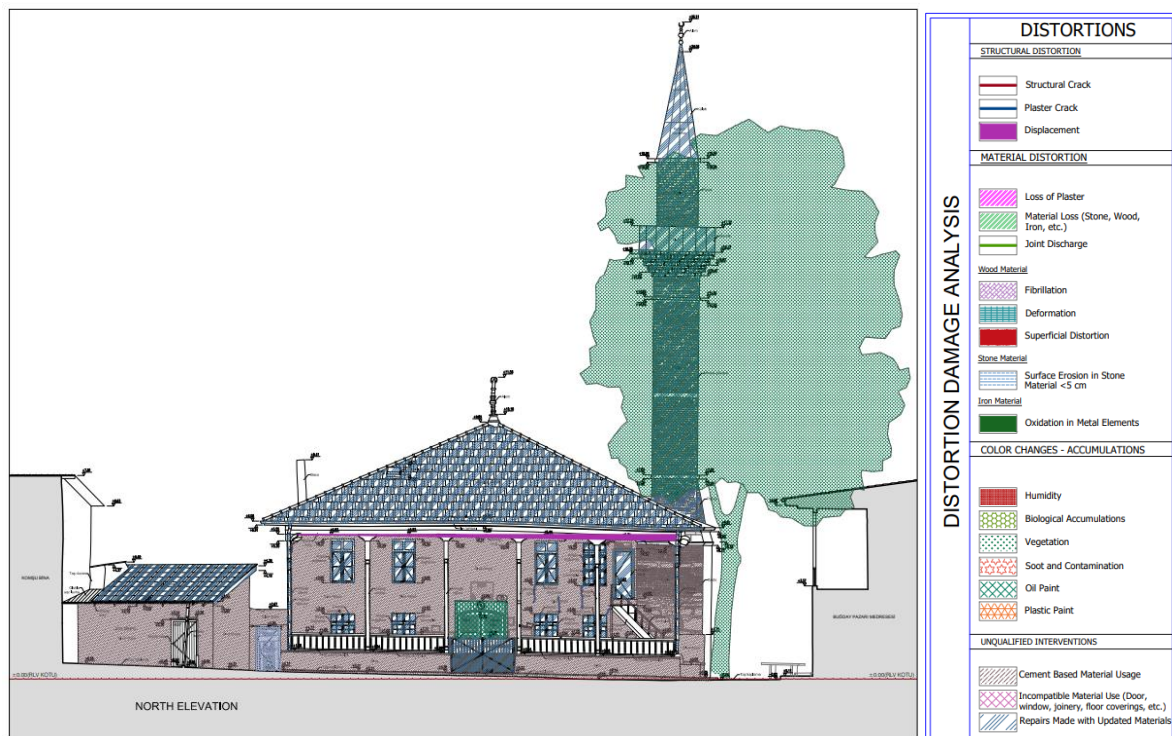
Figure 3. Layouts prepared in line with the detected deterioration and problems for Buğdaypazarı Mosque

The deterioration and damage in the building; Structural Distortions, Material Distortions, Color Changes and Unqualified Interventions were examined and worked on the Survey Distortion Sheet. Types of deterioration in the building are determined as "Plaster Crack", "Deflection", "Fibrillation", "Planting", "Oil Paint Applications", "Cement Based Material Use", "Incompatible Material Use" and "Repairs Made with Current Materials". The interventions to be made to the building in line with the detected deteriorations and problems were determined and accordingly, restoration projects were prepared.

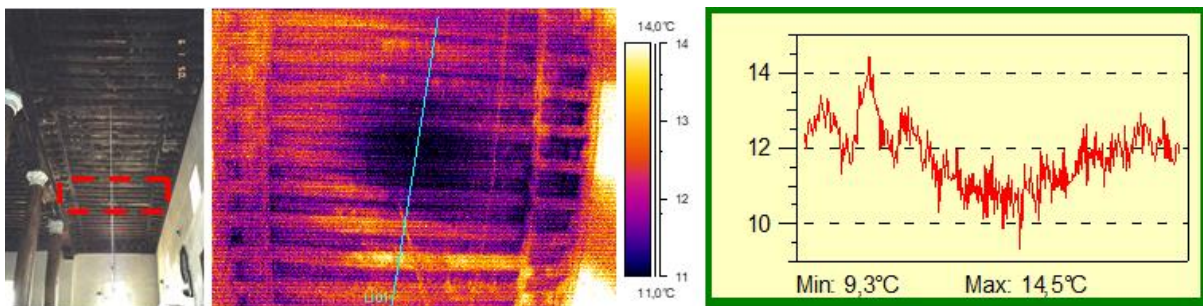
Figure 4. Wooden ceiling infrared thermal image and wood temperature curve

From the temperature curve showing the infrared thermal image of the area in the frame and the heat distribution on the wooden ceiling, we see that the temperature difference on the wooden ceiling surface reaches up to 5 C. This indicates that the cold area is wet and there are moisture problems in the ceiling caused by problems in the roof drainage system (Saltık:2008). For the definition of historical building materials, physical properties of unit weight and porosity are determined. As a result, it has been observed that the mortars have high porosity (31% - 60%) and low unit weight (1.16 g / cm³ - 1.42 g / cm³). Thin sections of some mortar and plaster samples taken from Arslanhane Mosque were prepared; mineralogical and petrographic definitions of aggregates and properties of binder materials.

Arslanhane Mosque, located in Altındağ District of Ankara, is one of the most magnificent examples of the Anatolian Seljuk Period mosques with wooden posts and wooden ceilings. The walls of Arslanhane Mosque were built with a masonry system and the wooden ceiling is carried by 24 wooden columns. Rubble stone, spolia material, bricks and wooden beams were used in the main walls of the building. The survey, restitution and restoration projects of the mosque were drawn by ANB Mimarlık İnşaat ve Ticaret Limited Şirketi. During the documentation phase, advanced documentation methods and traditional methods were used together. Historical research reports were prepared in coordination with the measurements. When the building was measured with a laser scanner and the survey drawings were made, it was determined that the columns carrying the roof were offset by 10-30 cm in the vertical axis and deflection in the ceiling beams. In addition, it has been observed that the moisture problem arising from the rain water that cannot be evacuated on the roof and the materials used in old dated repairs also cause problems in the building. In order to detect these problems, Infrared Thermal Imaging and Mortar and Plaster Analyzes regarding the superstructure were carried out by the METU Material Protection Laboratory. Infrared thermal images clearly show damp areas caused by faults in the roof drain assembly. In the infrared thermal images, the humidity problem rising from the bottom to the top of the building walls is also clearly seen.

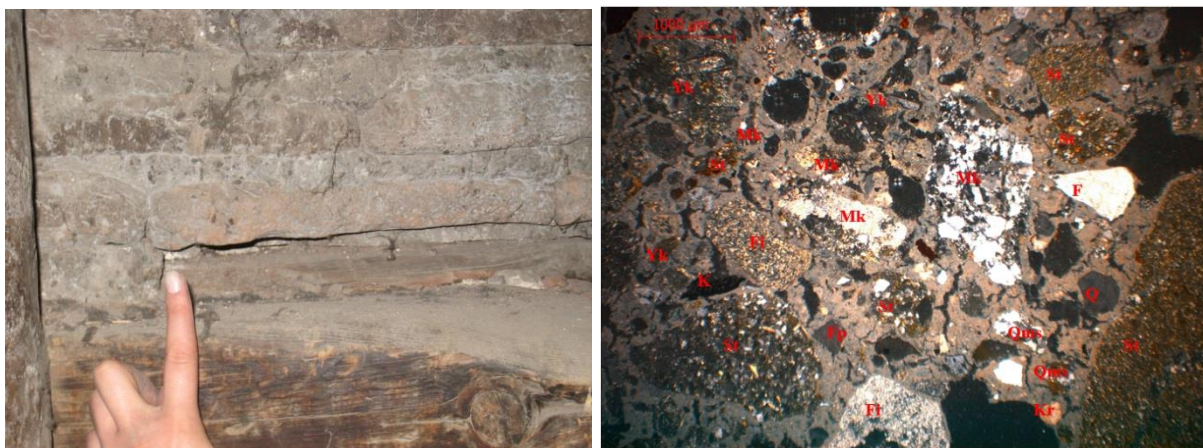
Figure 5. Lime mortar between wood and bricks on the steps of the minaret (left)

Figure 6. Thin section view of the inter-brick mortar sample (AC12) from the minaret F: Feldspar, Yk: Surface Rock Fragment, Mk: Metamorphic Rock Fragment, St: Siltstone, K: Coal fragment, Qms: Quartz-mica-schist, Fi: Fillite, Q: Quartz, Fp: Plagioclase feldspar, Kr: Limestone.

As a result of these analyzes and examinations, the problems in the structure were determined more accurately and solution suggestions were made. In addition, the content of mortars and plasters to be used in repairs was determined in line with the material analysis made. Based on these documentation studies, intervention decisions were made and restoration projects were prepared accordingly.

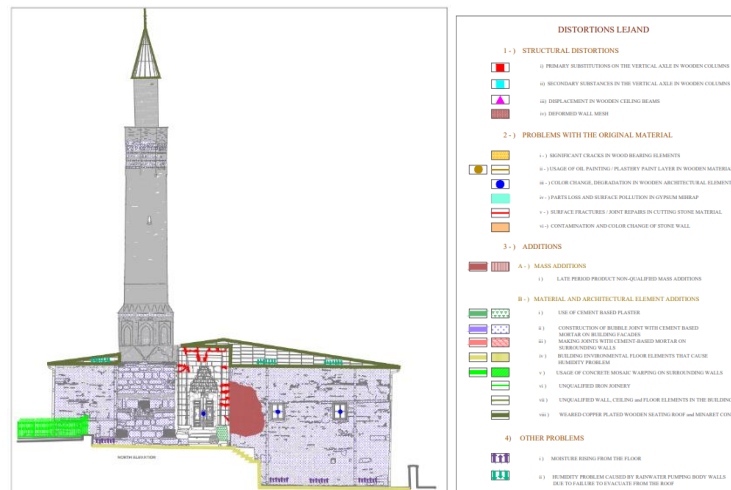
Figure 7. Layouts prepared in line with the detected deterioration and problems for Arslanhane Mosque¹

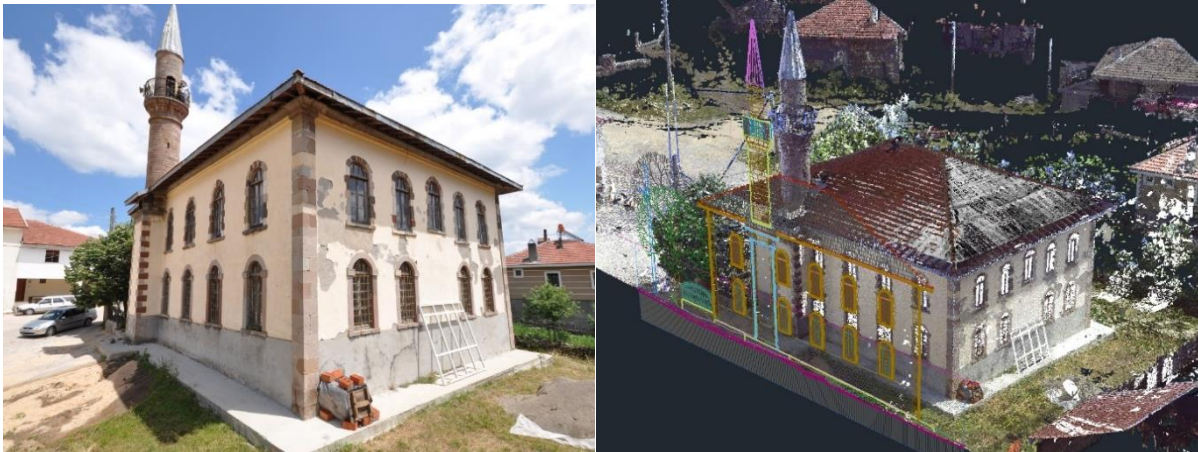
Figure 8. Hamidiye Mosque, northwest view and orthophoto view

Located in Bolu Province, Gerede District, Aşağıovacık Village Mosque was built by Sultan Abdulhamid II in H. 1309 / AD 1891-1892. It was understood that Hacı Habib Efendi, who was the chief carpenter of Sultan Abdülhamid, was built as a gift in his village upon his superior services and request. In a document dated 1903 in the Archives of the General Directorate of Foundations, it is seen that the name of the building is "Hamidiye Câmî-i Şerif". The survey, restitution and restoration projects of the mosque were drawn by Erk Architecture Office. Studies to document the current state of the building were carried out in two different digital media, namely "laser scanner and photo-video shooting". The current state of the building, its material and structural features, problems in the structure (types and reasons of material deterioration, structural problem, etc.) and the interventions of the building have been determined. Studies for the documentation of the current situation were completed as a result of the work of a team consisting of architects, art historians, civil engineers and restoration experts. Every bit of information obtained during the survey, restitution and restoration works formed the data (basis) of the next stage. In order for the project to achieve its goals, it was concluded by following the method of completing all phases in a healthy way and transferring the information between the phases correctly.

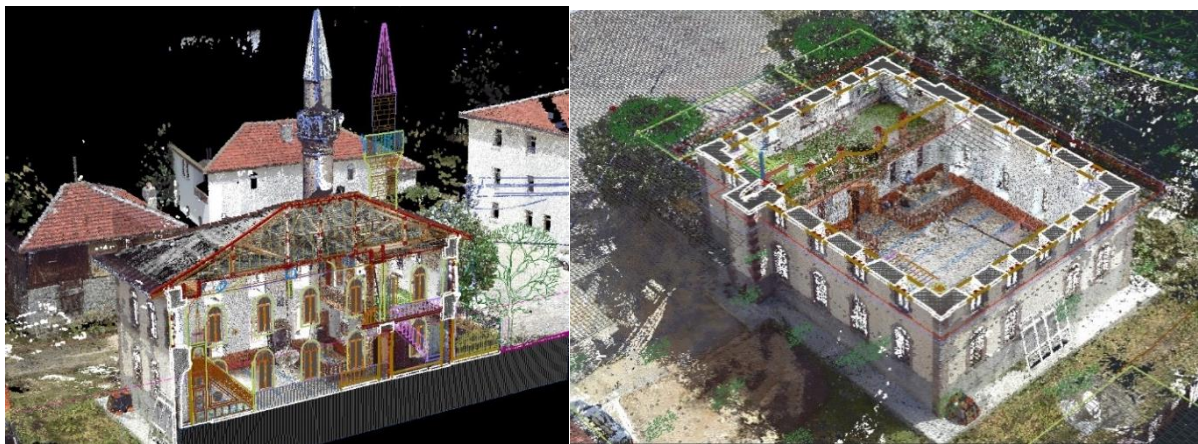
Figure 9. Hamidiye Mosque, section and plan orthophoto views

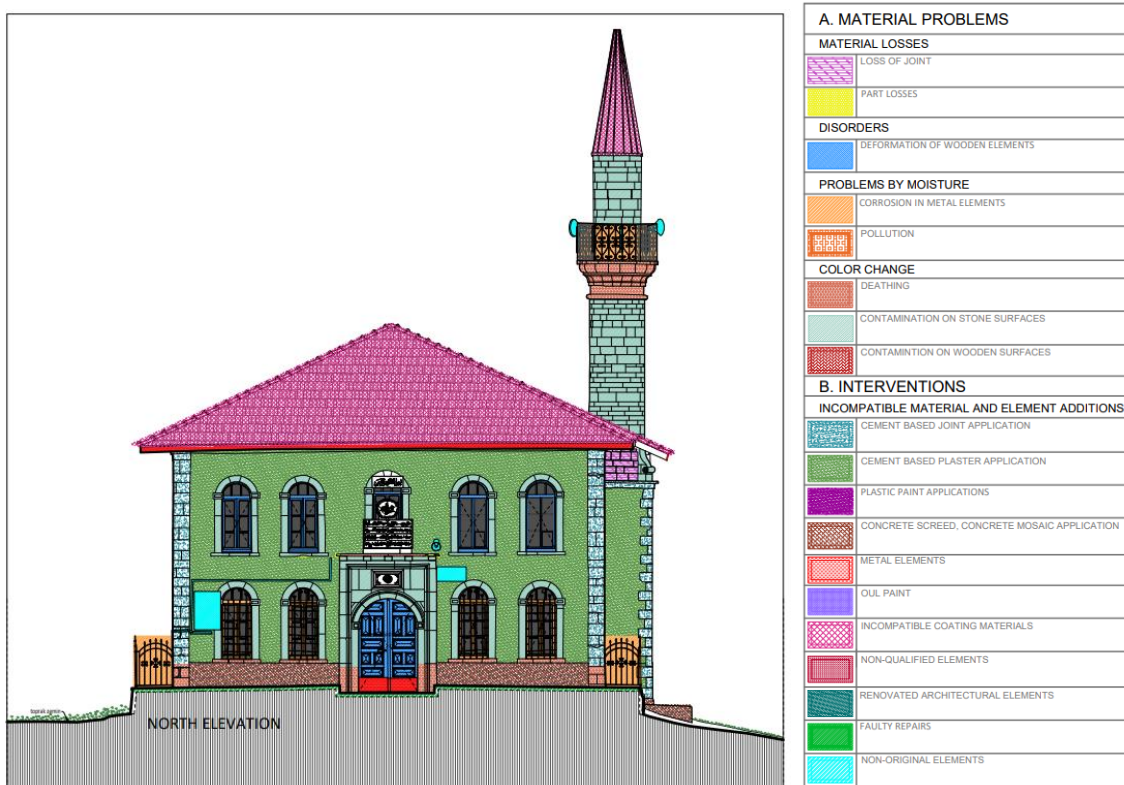
Figure 10. Layouts prepared in line with the detected deterioration and problems for Hamidiye Mosque
