The Eurasia Proceedings of Science, Technology, Engineering and Mathematics (EPSTEM), 2025

ICBASET 2025: International Conference on Basic Sciences, Engineering and Technology

Comparative Analysis of Measures to Reduce Wear on Ship Hull Structures in Areas Around Ballast System Suction Pipes

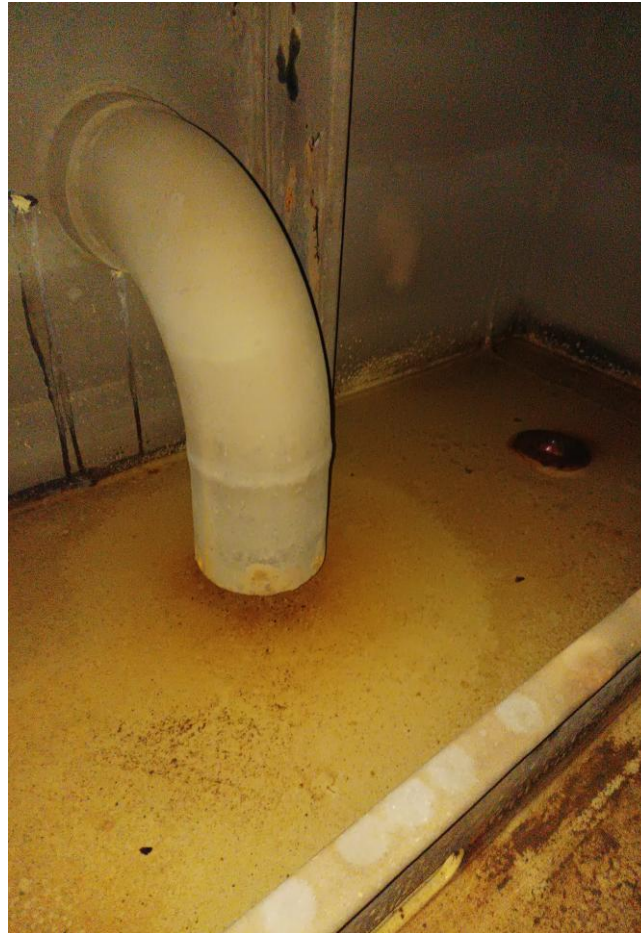
Figure 1. Option one without installed plate

The proposed comparison criteria are adapted and fully comply with real ship repair practices. The two comparison options are as follows. Option one is when the erosion resistance plate is installed during the ship hull repair stages, and option two is when the erosion resistance plate is installed during the ship hull building stage.

The surface preparation for repair in option one consists of burning off the paint around and under the suction pipe, welding, grinding the welded areas, installing, and welding the anti-erosion plate. The peculiarity here is that all these activities cannot be performed by two people simultaneously. This is precisely why the repair takes a longer time to complete.

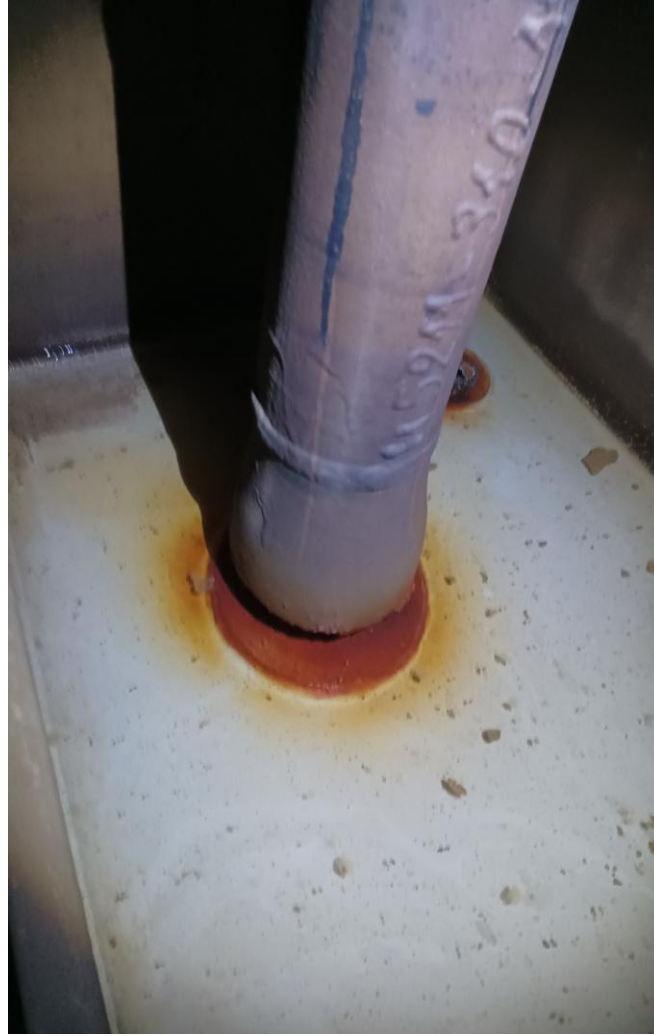
Figure 2. Option two with installed plate
